ID31 microstation – 20th, November 2017

Measurements made in the following conditions:

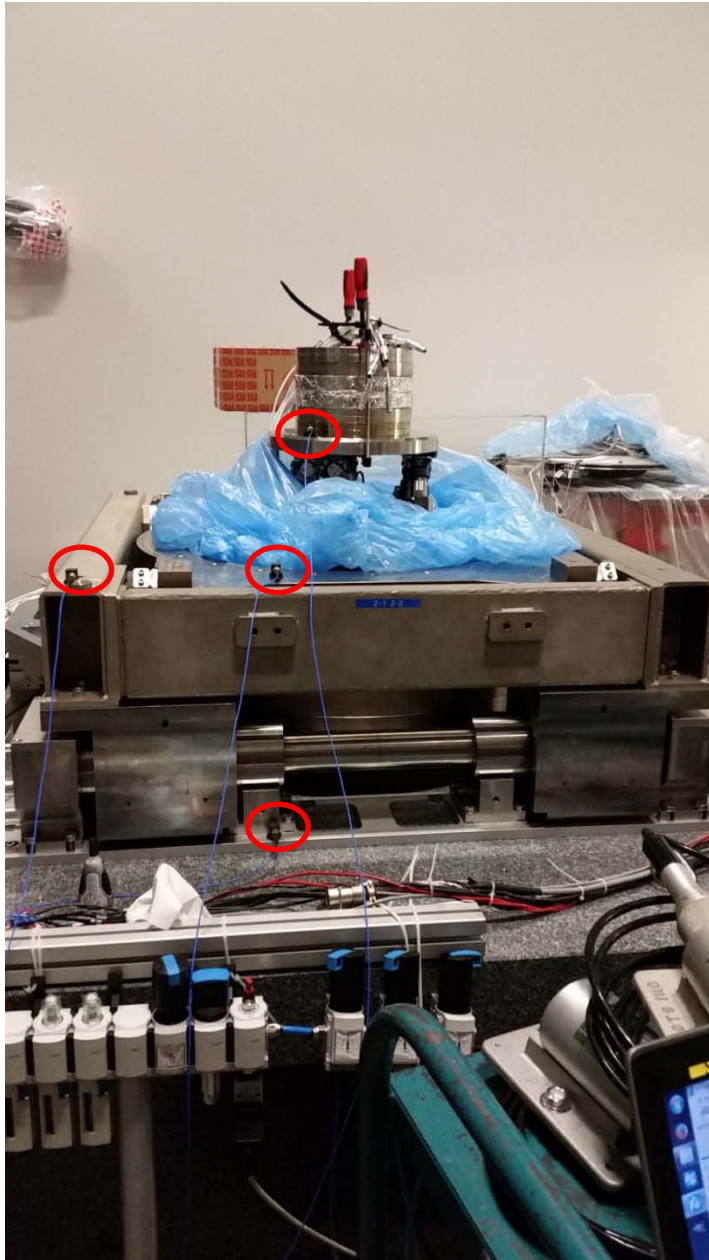
The 4 accelerometers

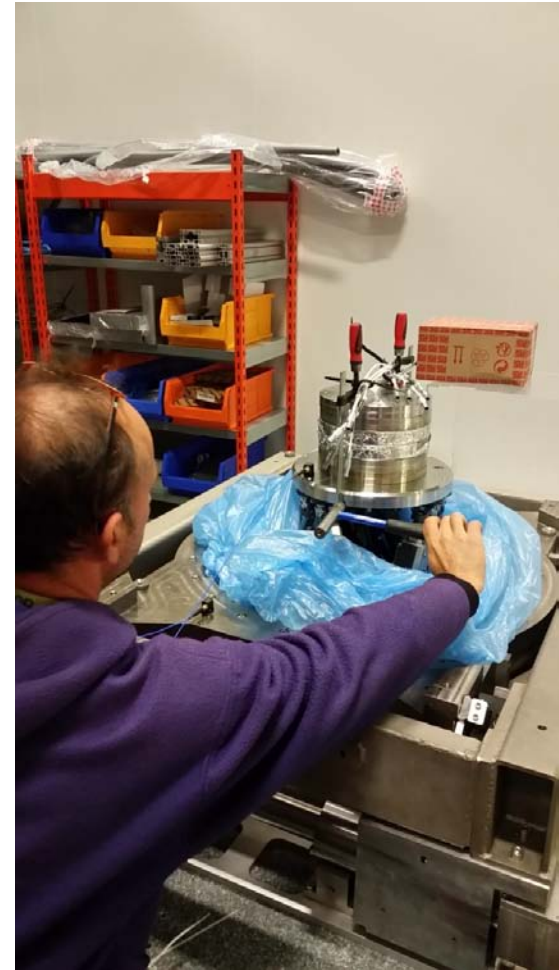
Excitation along X
